Arolwg Adeiladau Rhestredig mewn Perygl 2015

Adeiladau
sydd wedi'u
nodi **Mewn**
Perygl

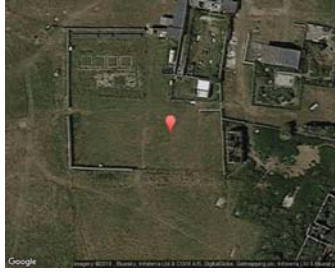
14094_1 - Laundry Building to former Isolation Hospital, Flat Holm

This building has not changed significantly since its previous inspection in 2006

●●●●●●●● **HAA Score - 9.91**
 Structurally unsound with multiple failures - loss may follow in short term

Major Repairs Required

▲ Chimneys (render), Wall Pointing, Wall Render (smooth)

Full Replacement Required

▲ Roof Covering (slate), Roof Flashings, Rooflights or Dormers (timber), Rain Water Goods (cast iron), Main Wall Structure (brick), Window Frames (timber), Window Glazing, Doors (timber)

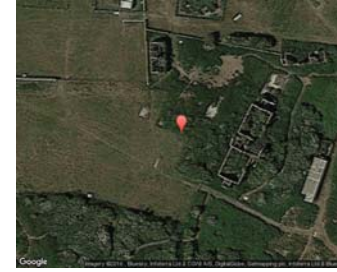
14093_1 - Former Isolation Hospital (Main Block) Flat Holm Island

This building has declined (high decline rate) since its previous inspection in 2006

●●●●●●●● **HAA Score - 12.26**
 Structurally unsound with multiple failures - loss may follow in short term

Minor Repairs Required

▲ Chimneys (render)

Major Repairs Required

▲ Wall Pointing, Wall Render (smooth)

Full Replacement Required

▲ Roof Covering (slate), Roof Flashings, Rain Water Goods (cast iron), Main Wall Structure (brick), Window Frames (timber), Window Glazing, Doors (timber)

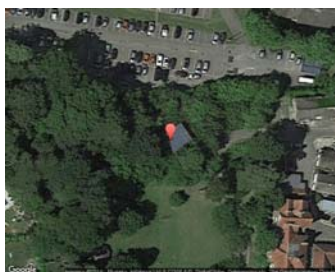
●●●●●● **HAA Score - 20.32**
 Condition is very poor, main structural elements serviceable but many items need

Full Replacement Required

⚠ Roof Covering (slate), Roof Flashings, Window Frames (timber), Window Glazing, Doors (timber)

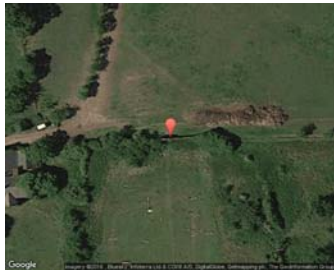
At Risk (3)
 This building has not changed significantly since its previous inspection in 2011
 Condition: **At Risk (3)**
 Occupancy: Structure

HAA Score - 21.42
 Condition is very poor, main structural elements serviceable but many items need
 15.65% - chance of decline (Low)
 -4.34% - predicted HAA Score reduction per year (Elevated)

Major Repairs Required
 Main Wall Structure (brick), Wall Pointing

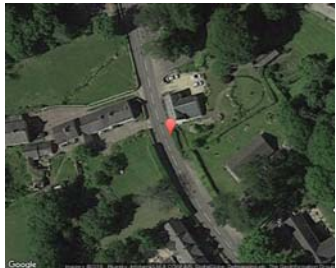
Speed of decay may be increasing, some items will now or soon need replacement

Major Repairs Required

Main Wall Structure (stone)

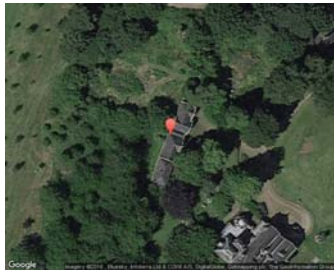
HAA Score - 41.02
 Condition may decline quickly if action is not taken, multiple items need attention

Full Replacement Required

Rain Water Goods (cast iron and other)

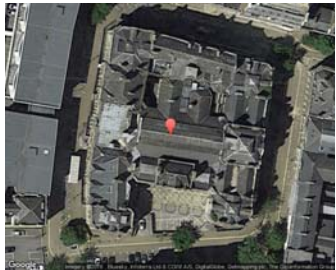
Condition deteriorating, action is now required to multiple defects to halt the decline

Major Repairs Required

Rain Water Goods (cast iron and other), Window Glazing
