CARDIFF CITY CENTRE

CONSERVATION AREA APPRAISALS

CARDIFF

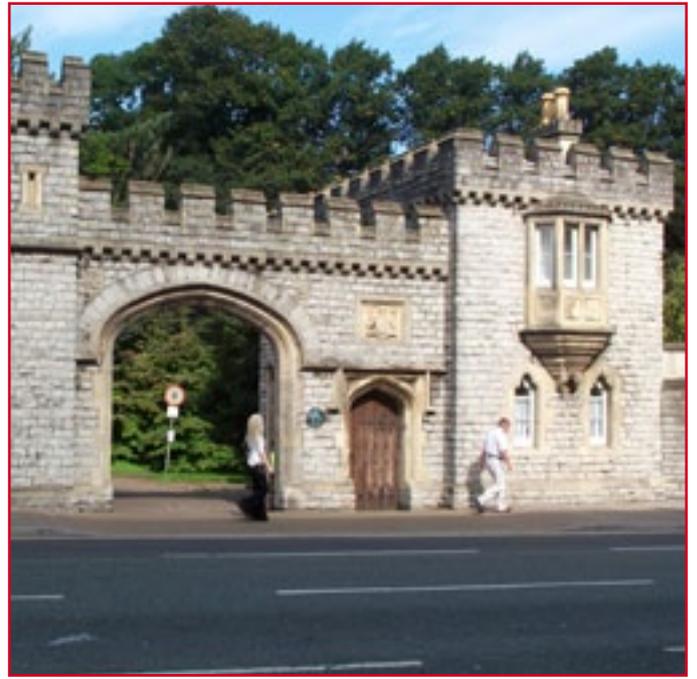
Cardiff Castle:

The south west face of the castle is dominated by the array of towers created by William Burges for the 3rd Marquis of Bute.

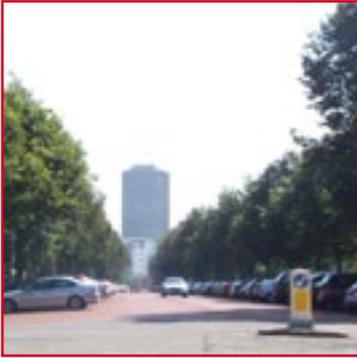
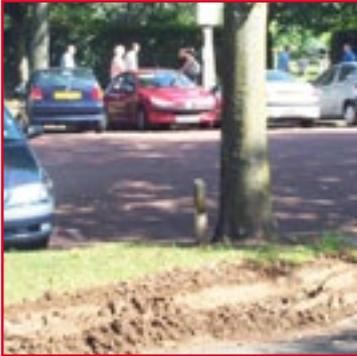
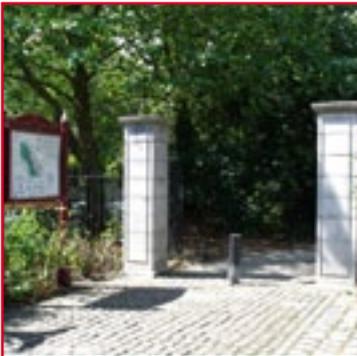
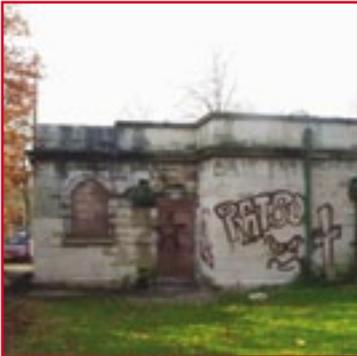
- Avenues of Mature Trees.
- Damaged Grass Verges.
- Understated Entrances to Bute Park.
- Disused Listed Public Toilet Building.

- The grass verges along Museum Avenue and King Edward VII Avenue are susceptible to damage by vehicles accessing forecourts and pedestrians walking to parked cars.
- Major events can cause damage to grassed areas in Bute Park, the Civic Centre and City Hall Lawn.

- There is limited on street promotion of the historic context of the Civic Centre and its prominent buildings.
- The listed public toilet building at Museum Avenue is derelict and is susceptible to graffiti and vandalism.
- The Dock Feeder Canal along Boulevard de Nantes is hidden behind overgrown foliage and lacks onsite promotion and interpretation.
- The remains of the Blackfriars Friary within Bute Park are vulnerable to damage and lack onsite interpretation.
- Historic walls located along North Road originally formed part of the boundary to Bute Park, but have become isolated between the highway and car parking areas.

- Through tree management and planting programmes, continue to maintain and enhance the avenues of trees along King Edward VII Avenue and Museum Avenue.
- To reinstate and maintain areas of worn or damaged green space throughout the area and investigate opportunities to protect those areas that are susceptible to repeated damage.
- To progress the recommendations of the HLF funded Bute Park Restoration and Development Plan (March 2005 / updated March 2006) and associated maintenance and management plans, including events management plan.
- To prepare and implement a restoration and development plan for the Cathays Park Civic Centre parks in line with the Parks Partnership Programme (2004).

- To improve the public's awareness of the area's built / natural heritage and landmark buildings, through the introduction of interpretative information and onsite signage / tourist information.
- To investigate alternative uses for the disused toilet block at Museum Avenue and opportunities to bring it back into beneficial use.
- To improve the setting / appearance of the Dock Feeder Canal along Boulevard de Nantes through improved management and improve the public's awareness through the introduction of interpretative signage.
- To preserve and enhance the remains of the Blackfriars Friary within Bute Park and improve the public's awareness through the introduction of interpretative signage.

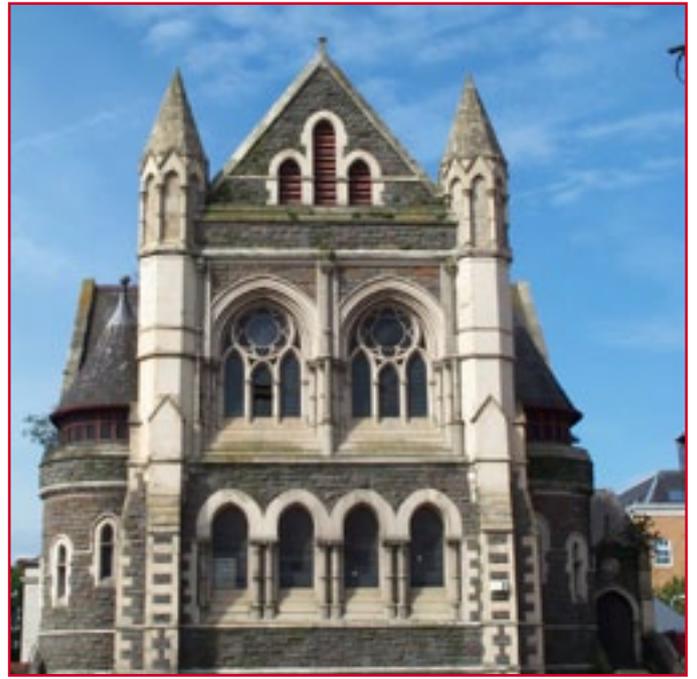
Built 1877 by architect Henry C. Harris as a Welsh Calvinistic Methodist Chapel in an Early French Gothic style, showing strong influences from the architect Williams Burges.

The architect has used Pennant stone in a French gothic style; towers, turrets and decorative stair towers rise above a basement area.

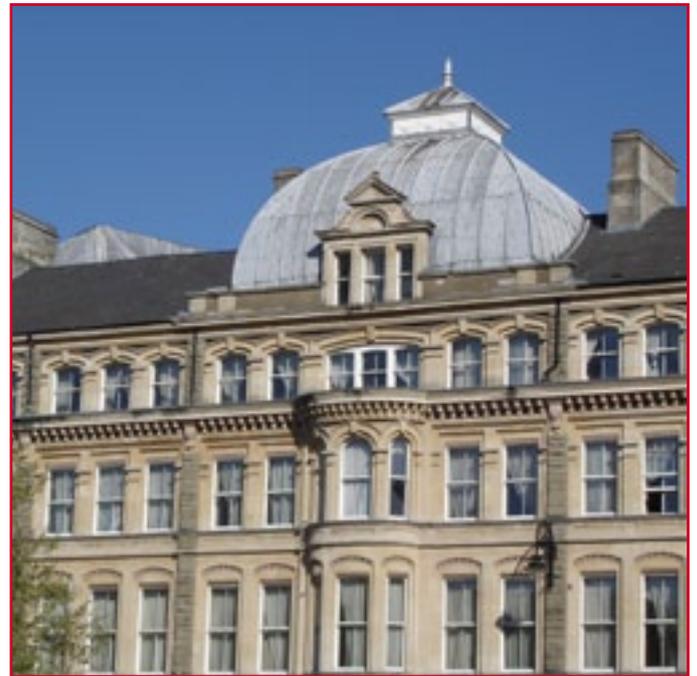
Park Hotel, Park Place / Queen St

Building dated 1884 featuring Forest of Dean sandstone (ground floor) and Pennant sandstone, Bath stone and terracotta (above). Listed as a well preserved French Renaissance style hotel by leading local architects. Of note: pavilion roof and decorative detail.

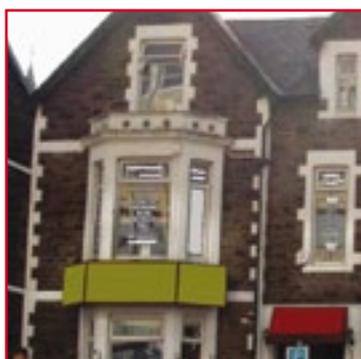
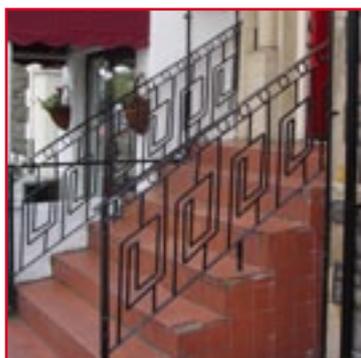
Whilst signage, extensions and alterations to boundary treatments have altered over time they have not until recently undermined the overall consistency of the group. Some modern signage on buildings and at street level is inappropriate to the style of building and creates an impression of unnecessary clutter.

The street frontages (steps and forecourts) of some properties have been effectively restored with appropriate tiling and replacement railings. Others are in a very poor state of repair; some front steps have lost their original balustrades and are often resurfaced in inappropriate period tiles or materials such as black slate. Security cages over some basement windows also detract from the quality of the townscape.

- Forecourt boundary railings.
- Loss of boundary walls to the rear.
- Modern signage and canopies.
- Steps and railings that are out of character with the property.

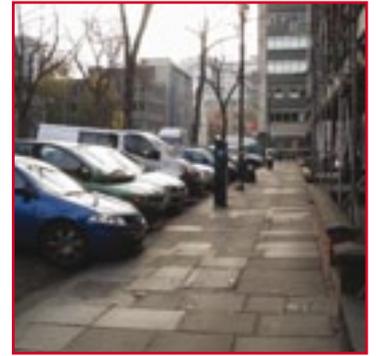
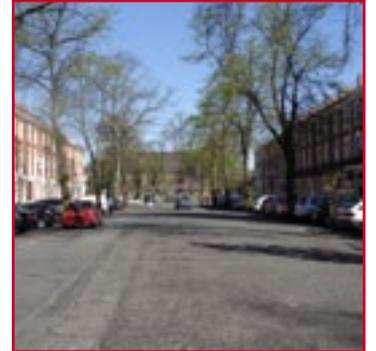
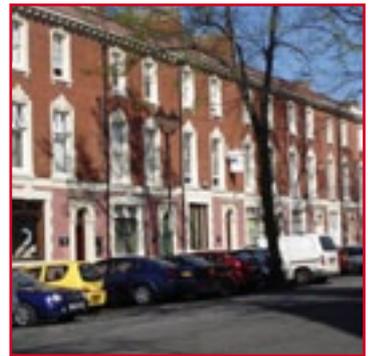
- Public on-street parking at Windsor Place and St Andrews Crescent has had a negative impact on the character of the Conservation Area, both visually and through conflict between motor vehicles and pedestrians, as well as through damage to street trees.

- Rear lanes are in poor condition with setts/cobbled surfaces patched or covered with other materials.

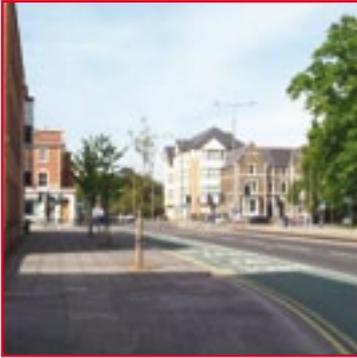
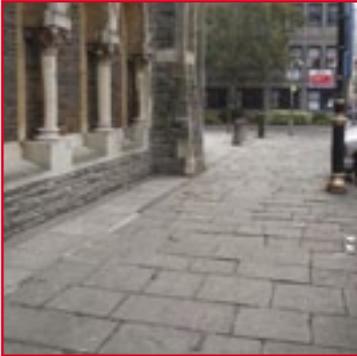
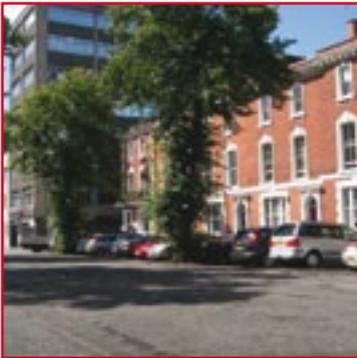
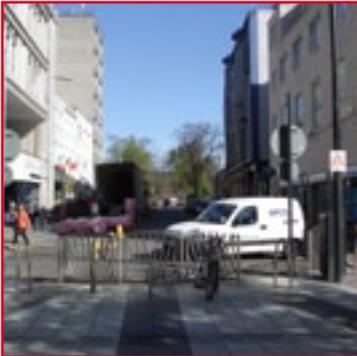
- Inconsistent use of paving materials.
- Wide expanse of tarmac at Windsor Place.
- On street parking throughout the area.
- Poor legibility between Queen Street and Windsor Place.

- Stuttgarter Strasse separates Windsor Place from St Andrews Crescent.
- Original pennant paving.
- Mature street trees.
- View into Windsor Place from Queen St.

- Seek to retain and enhance the historic character of Windsor Place including: reinstating pennant paving, continuing the programme for street tree maintenance and, where necessary, replacement of trees, creating high quality forecourt boundary treatments and reducing the impact of vehicles using the area.
- Seek to enhance the public realm at the junction of Windsor Place and Queen Street to improve pedestrian priority, enhance views and aid legibility.
