CARDIFF CITY CENTRE

CONSERVATION AREA APPRAISALS

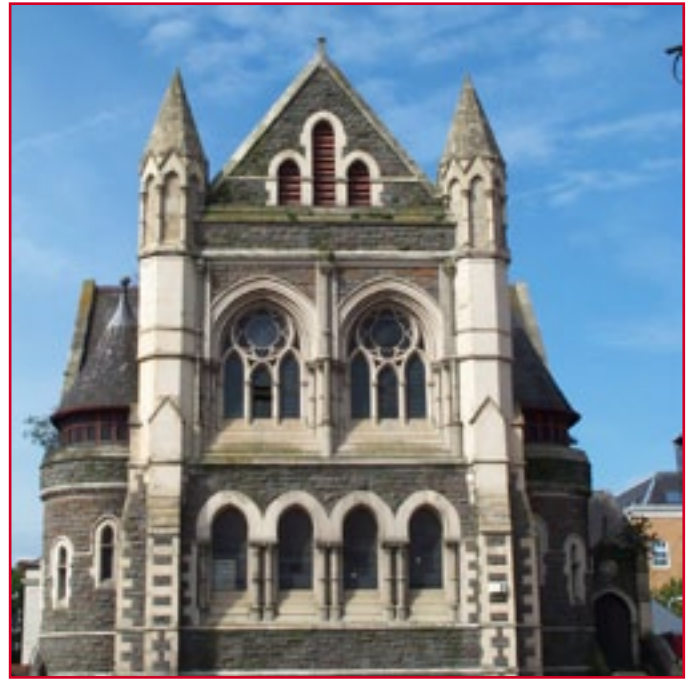
Built 1877 by architect Henry C. Harris as a Welsh Calvinistic Methodist Chapel in an Early French Gothic style, showing strong influences from the architect Williams Burges.

The architect has used Pennant stone in a French gothic style; towers, turrets and decorative stair towers rise above a basement area.

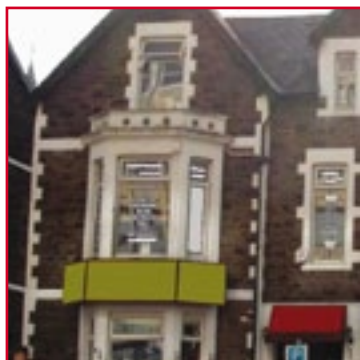
Houses on Churchill Way are faced in hammer dressed Pennant stone, partnered by Bath stone dressings with canted bays, gothic style arches and gabled roofs. Whilst the overall style is the same between pairs, there are variations in the combination of architectural elements and detailing, especially on porches, gables and window bays.

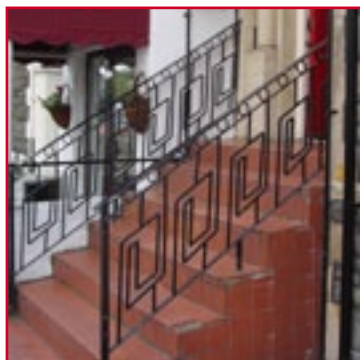
The street frontages (steps and forecourts) of some properties have been effectively restored with appropriate tiling and replacement railings. Others are in a very poor state of repair; some front steps have lost their original balustrades and are often resurfaced in inappropriate period tiles or materials such as black slate. Security cages over some basement windows also detract from the quality of the townscape.

- Forecourt boundary railings.
- Loss of boundary walls to the rear.
- Modern signage and canopies.
- Steps and railings that are out of character with the property.

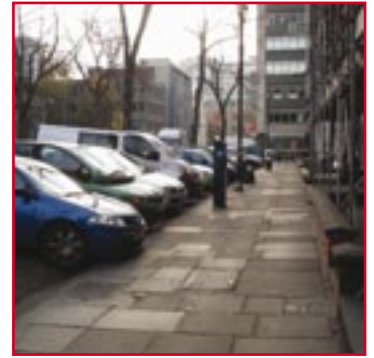
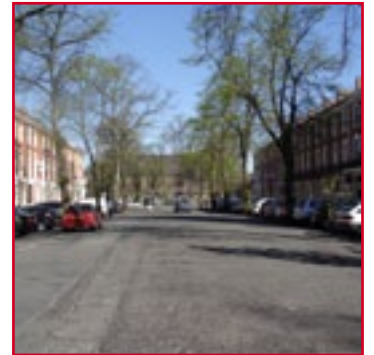
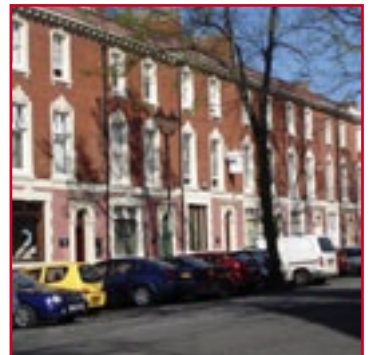
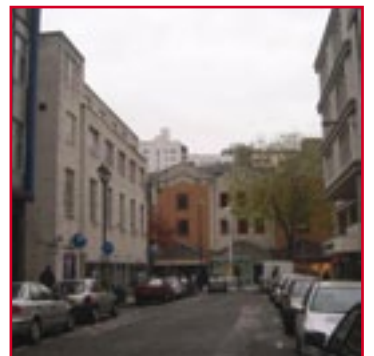
- Inconsistent use of paving materials.
- Wide expanse of tarmac at Windsor Place.
- On street parking throughout the area.
- Poor legibility between Queen Street and Windsor Place.

- Seek to retain and enhance the historic character of Windsor Place including: reinstating pennant paving, continuing the programme for street tree maintenance and, where necessary, replacement of trees, creating high quality forecourt boundary treatments and reducing the impact of vehicles using the area.
- Seek to enhance the public realm at the junction of Windsor Place and Queen Street to improve pedestrian priority, enhance views and aid legibility.
